Pier 4 Phase 1
Removal Action Project

Time Critical Removal
Action Completion Report

July 2016

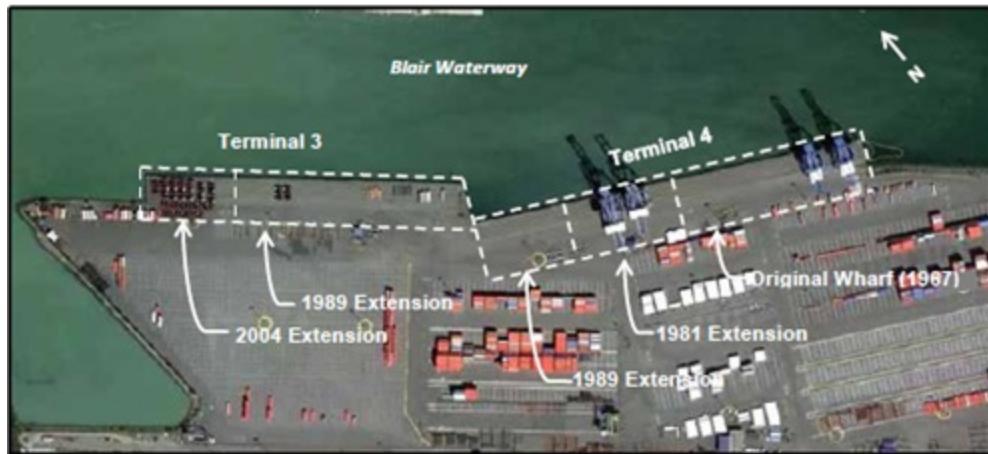
Photograph 1. Aerial view of Husky Terminal and dates of construction (Cardno TEC et al. 2012)

Pier 4 was constructed over a period of years starting in 1967 and ending in 1989. In 1967, the original wharf was constructed from pile Bents 35 through 76 at the south end of the pier, as shown in Photograph 1. In 1981, the pier was expanded from Bent 35 through 20 in the Pier 4 Extension Project, and Bents 1 through 20 were later added in 1989 as part of the Terminal 3 and 4 Wharf Construction Project (Cardno TEC et al. 2012).

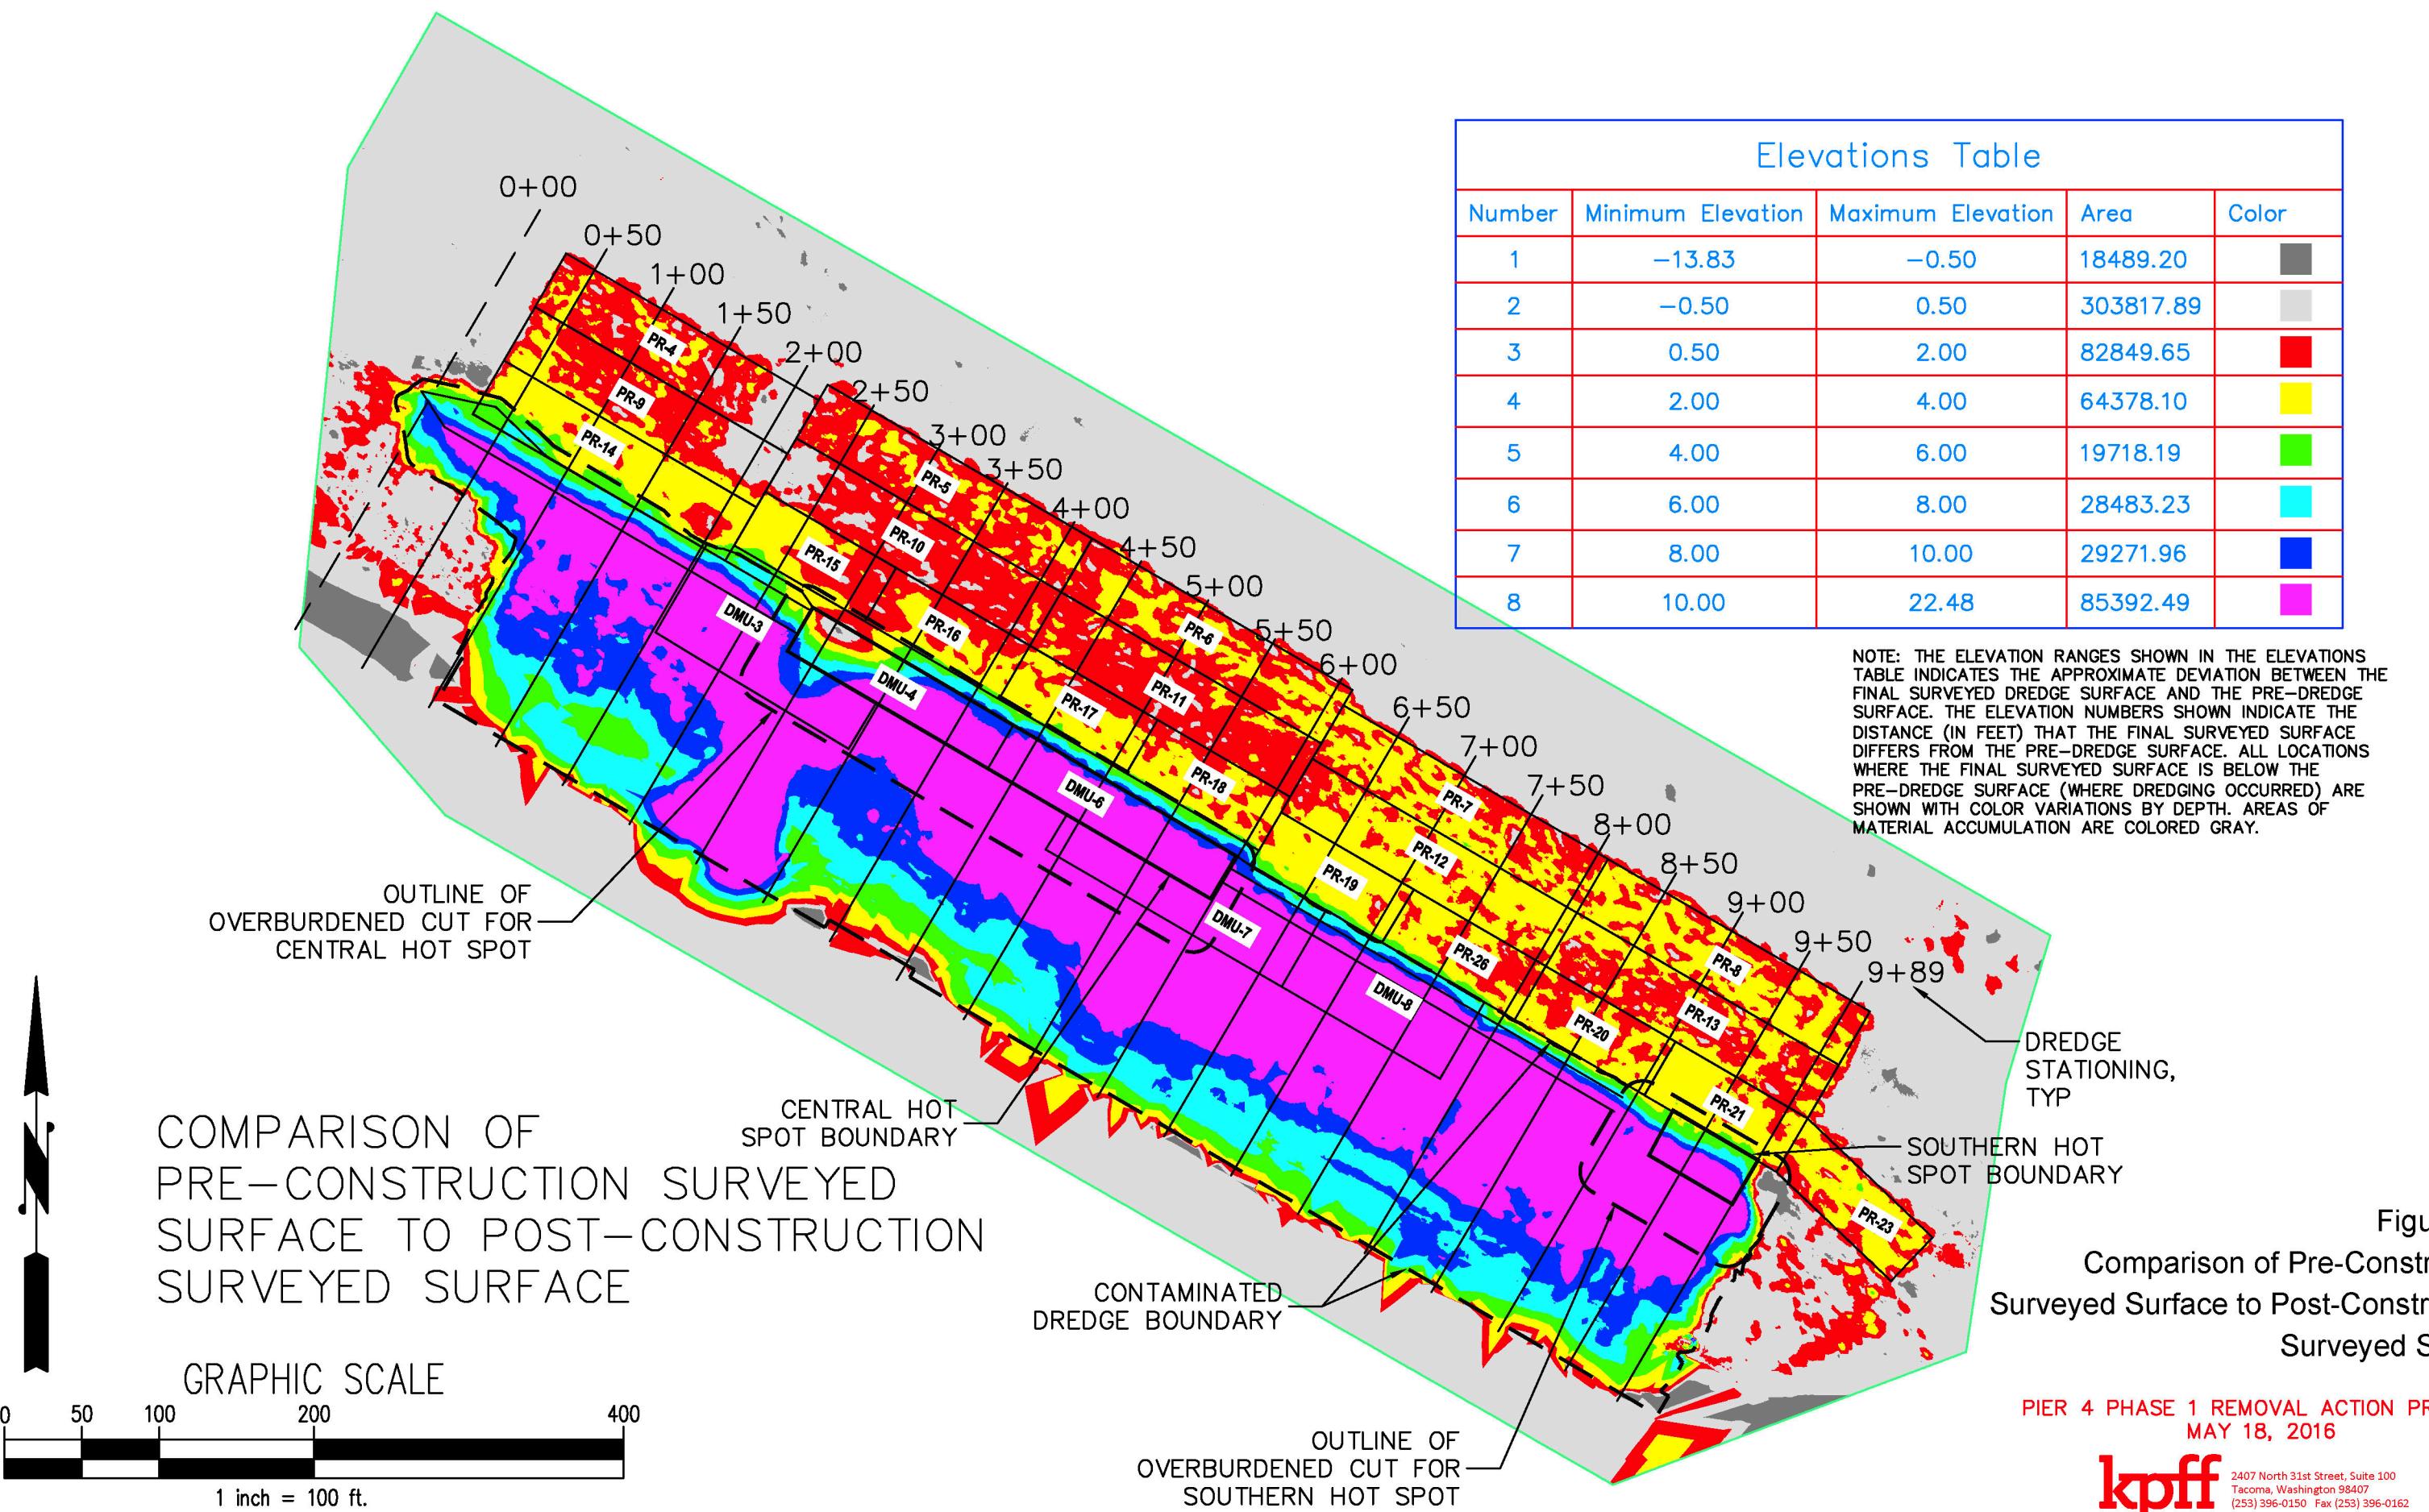
Figure 5.4

Comparison of Pre-Construction Surveyed Surface to Post-Construction Surveyed Surface

THIS SURFACE COMPARISON CROSS SECTION WAS COMPILED FROM DATA OBTAINED FROM THE CONSTRUCTION DESIGN DRAWINGS PREPARED BY KPFF AND BATHYMETRIC SURVEY INFORMATION PROVIDED BY THE CONTRACTOR.

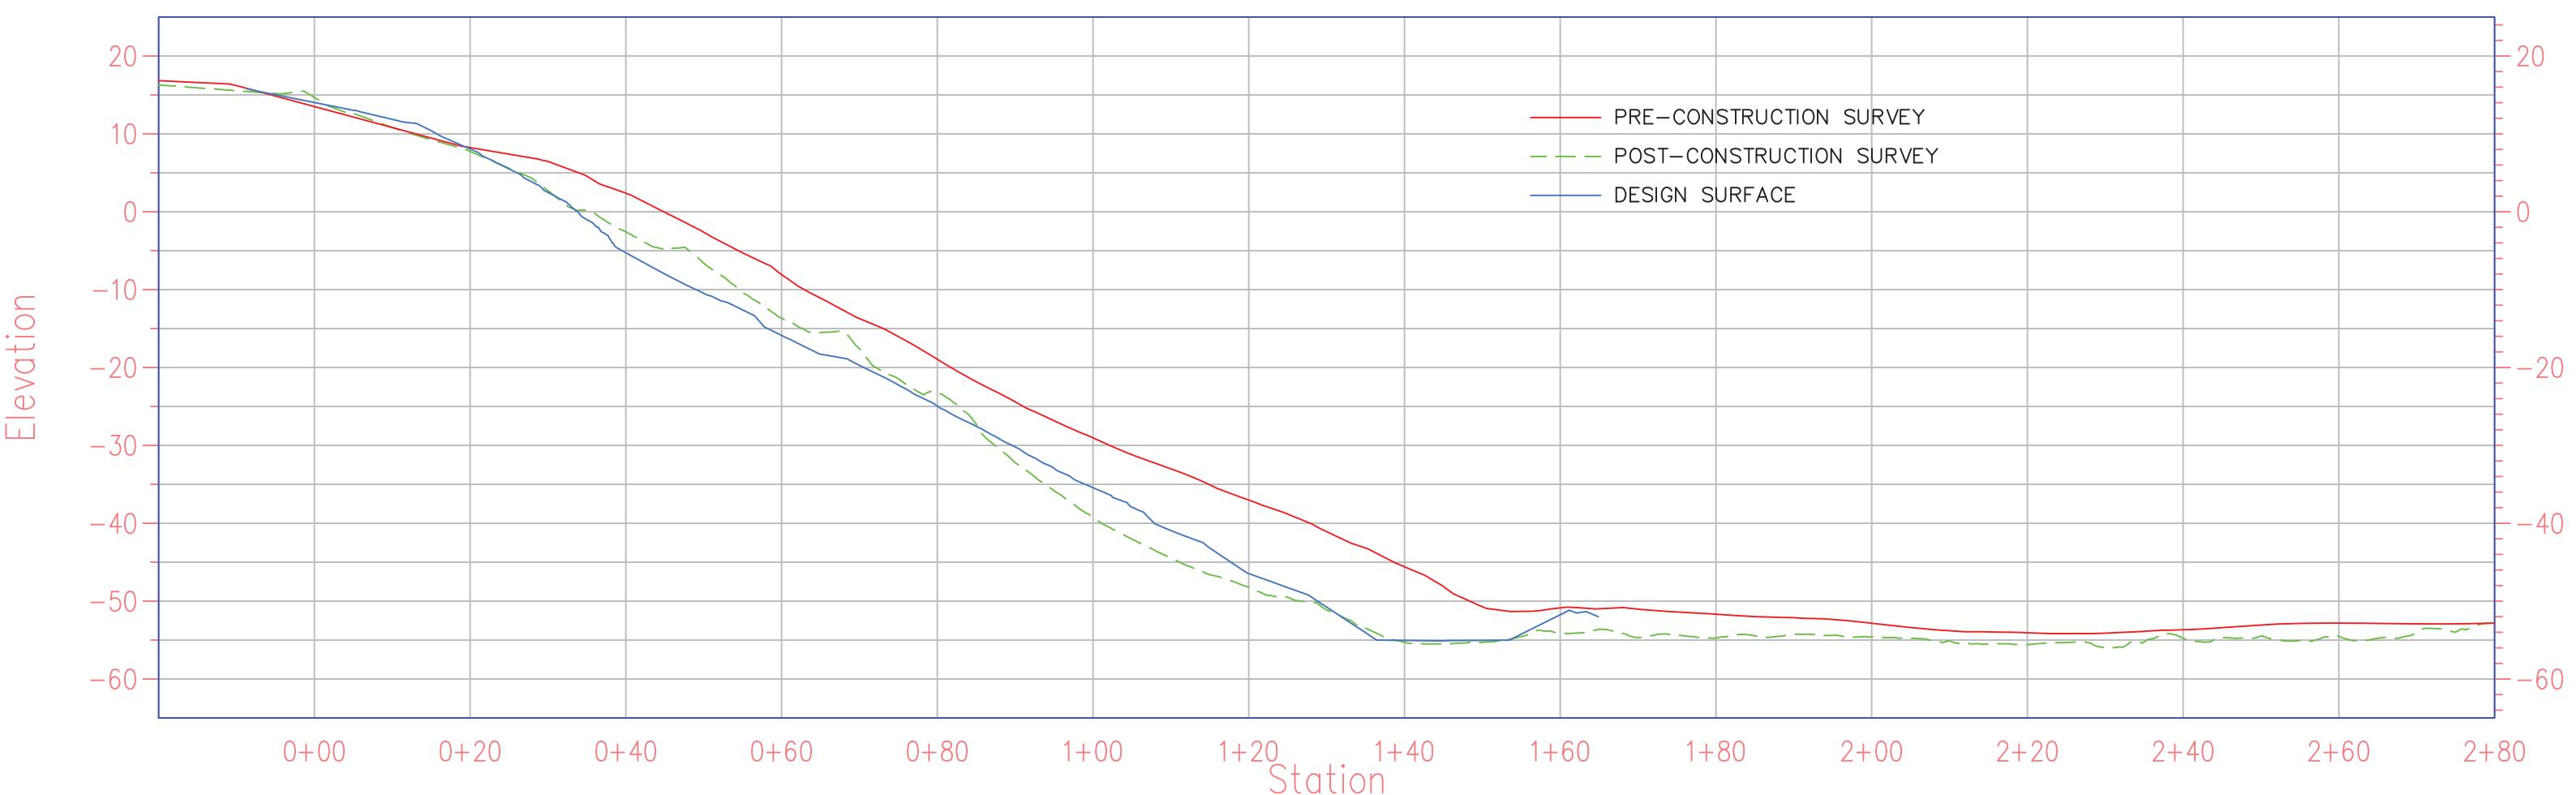
Figure 5.5
Dredge Section 1+00

THIS SURFACE COMPARISON CROSS SECTION WAS COMPILED FROM DATA OBTAINED FROM THE CONSTRUCTION DESIGN DRAWINGS PREPARED BY KPFF AND BATHYMETRIC SURVEY INFORMATION PROVIDED BY THE CONTRACTOR.

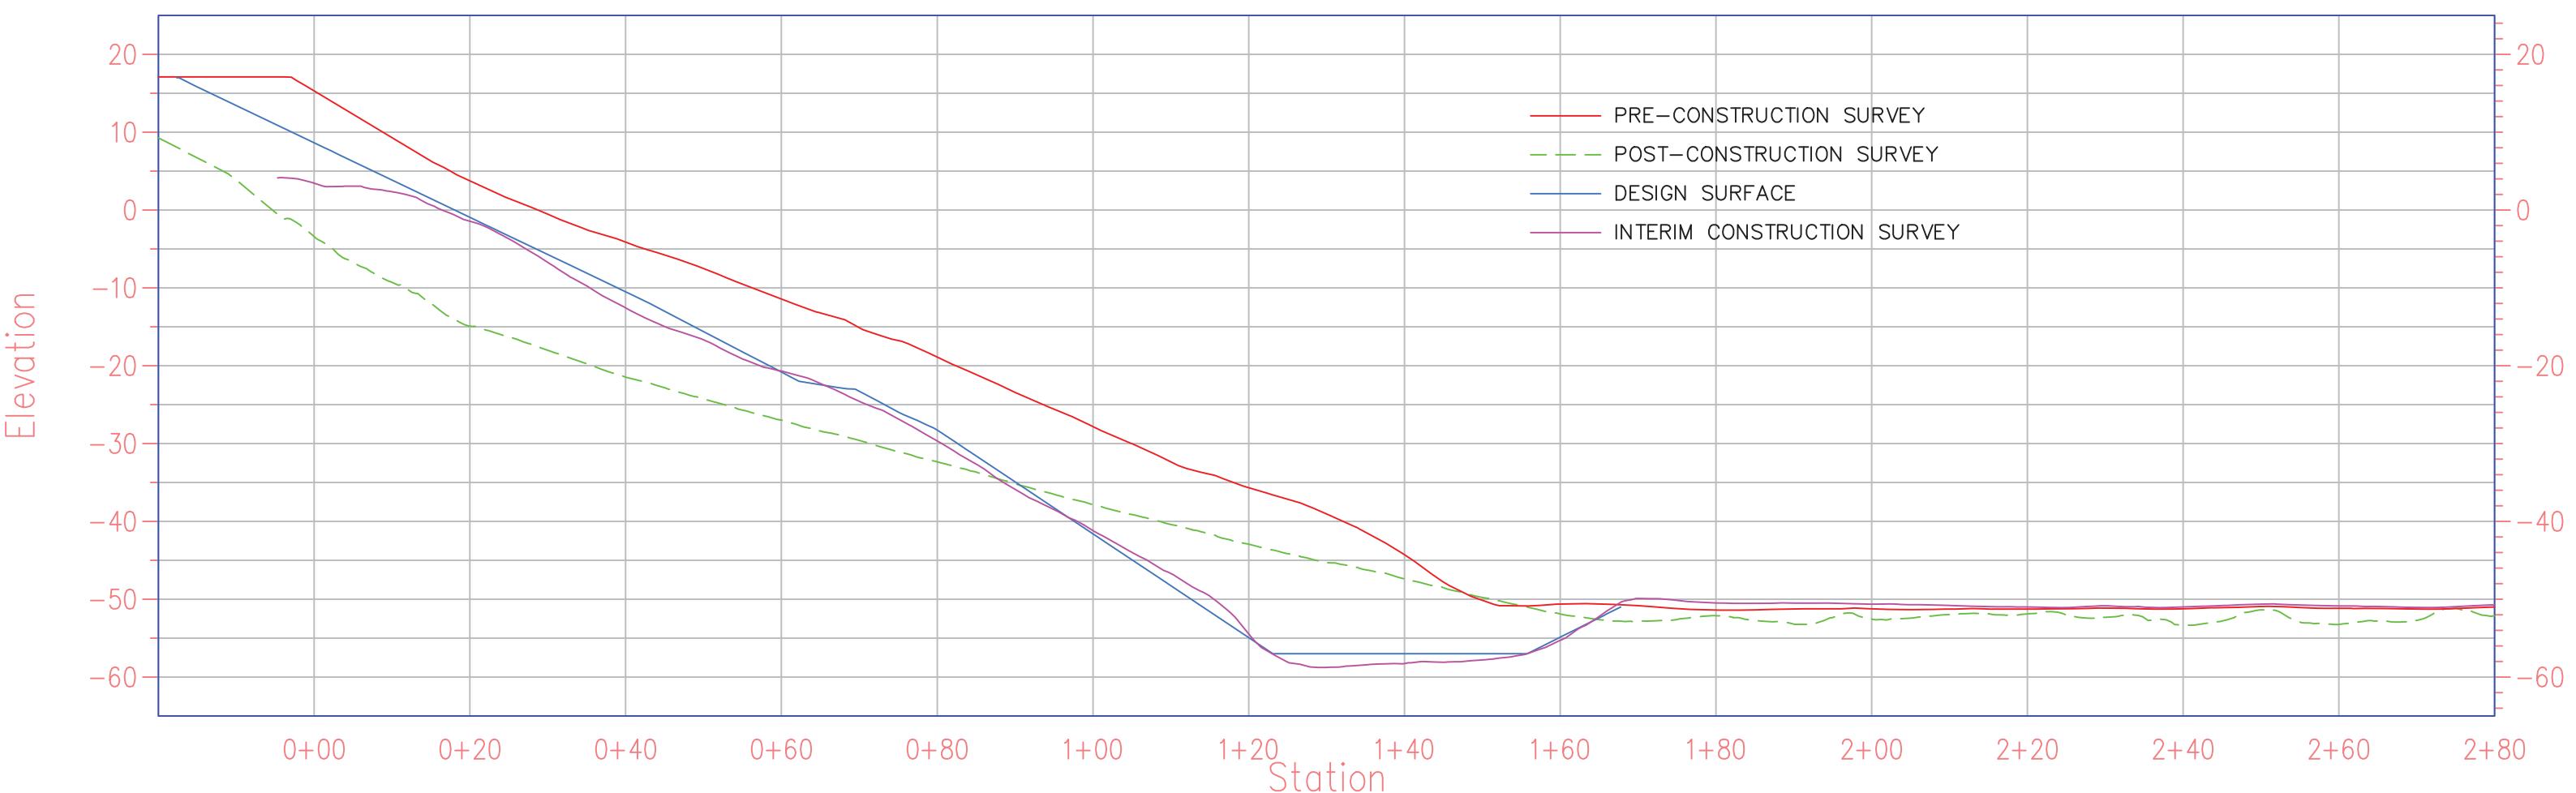
Figure 5.6
Dredge Section 3+00

THIS SURFACE COMPARISON CROSS SECTION WAS COMPILED FROM DATA OBTAINED FROM THE CONSTRUCTION DESIGN DRAWINGS PREPARED BY KPFF AND BATHYMETRIC SURVEY INFORMATION PROVIDED BY THE CONTRACTOR.

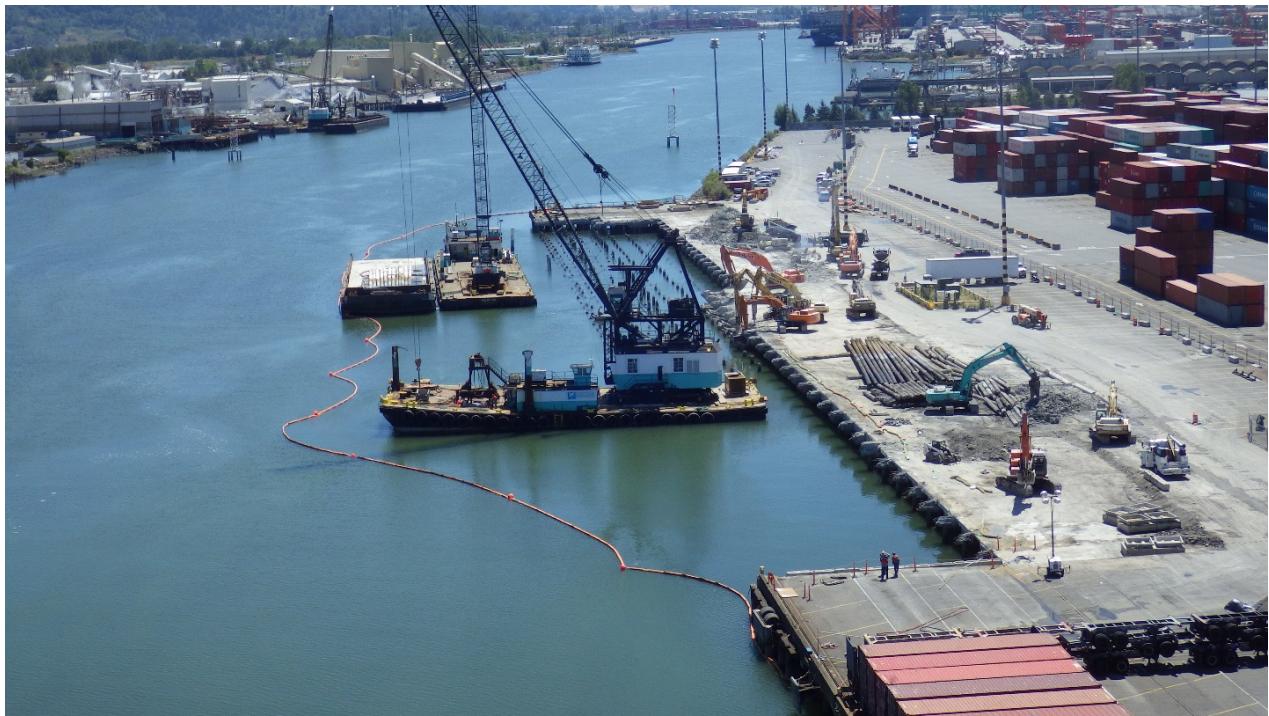
Photograph 1. Temporary floating boom and pile pulling.

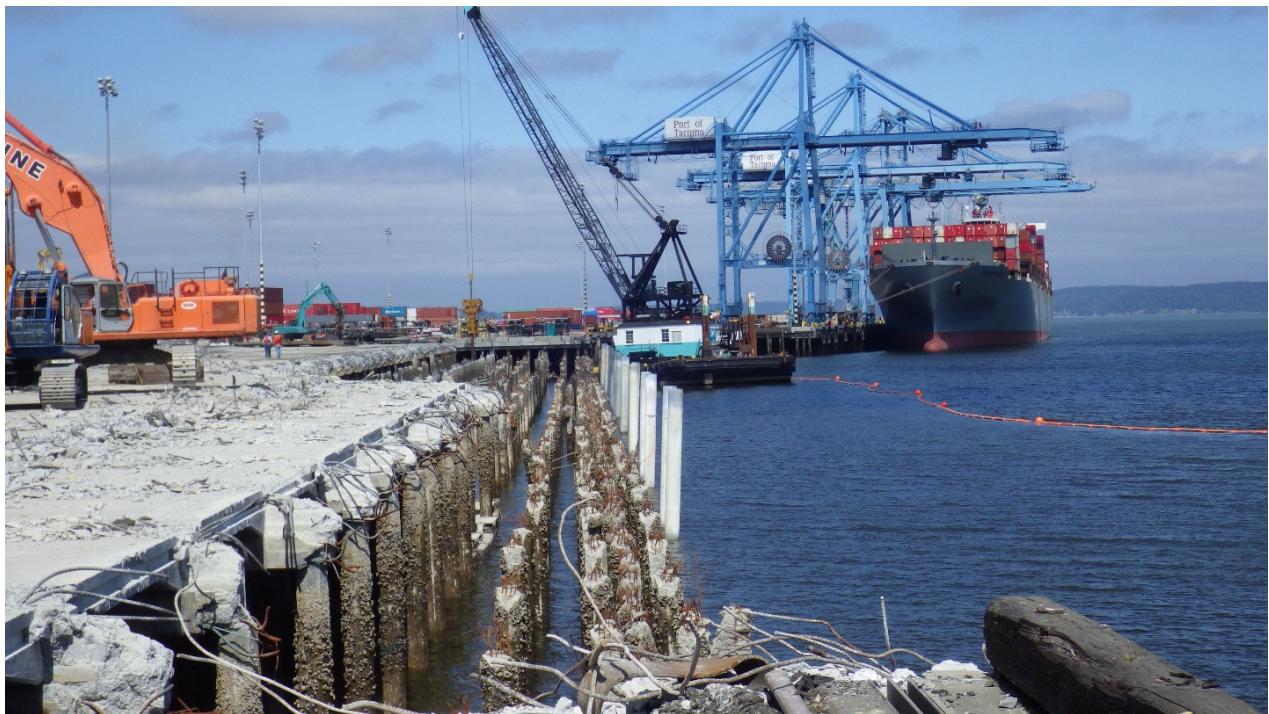
Photograph 2. Demolition of the pier.

Deck asphalt removal began on May 1, 2015. On May 11, 2015, Rhine began demolition of the bull rail, pier deck panels, and pile caps, starting from the north and working to the south (Appendix A, Photograph 2). All material was stockpiled on the pier for eventual off-site disposal or recycling (Appendix A, Photograph 3). Ballast removal also started on May 11, 2015. During removal of ballast, Rhine observed oil staining within the excavated material from the southern portion of the pier (Appendix A, Photograph 4). The Port tested the material to determine the appropriate disposal requirements. Results indicated that oil-range TPH were present (refer to Appendix B). The Port and Orion determined that additional samples should be taken because the initial sample was taken from surface material and the discoloration increased with depth during excavation. The second set of analytical results indicated that a portion of the material contained oil-range TPH. The Port directed Orion to dispose of the contaminated material, and 1,979 tons of ballast were taken to LRI. The Port also tested the ballast from the northern portion of the pier. The analytical results indicated that this ballast did not contain TPH.

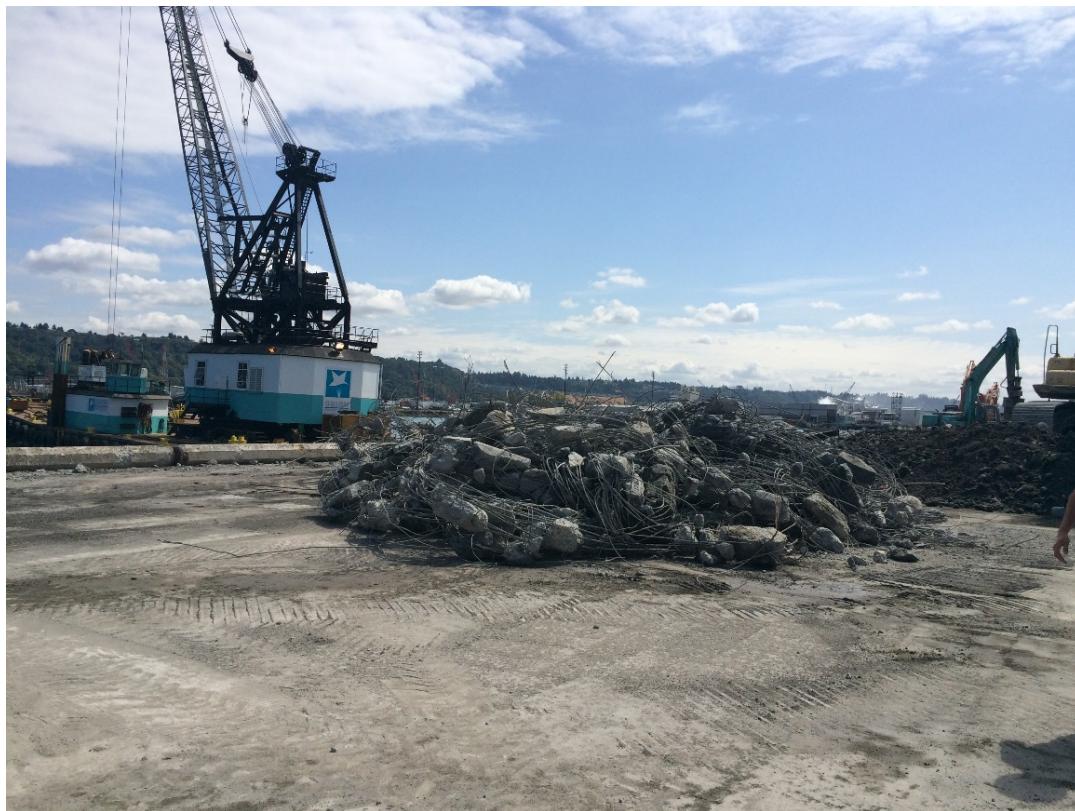
Photograph 3. Temporary stockpile of concrete and rebar.

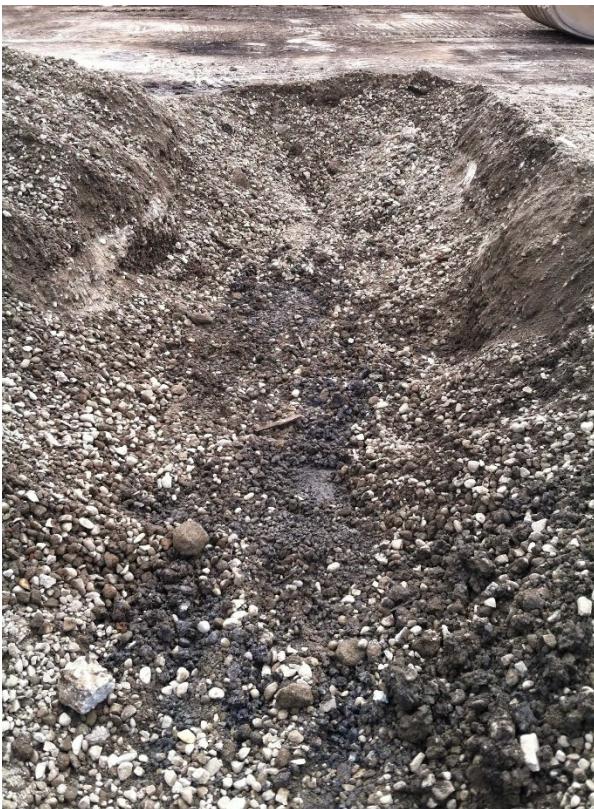
Photograph 4. Oil-impacted ballast.

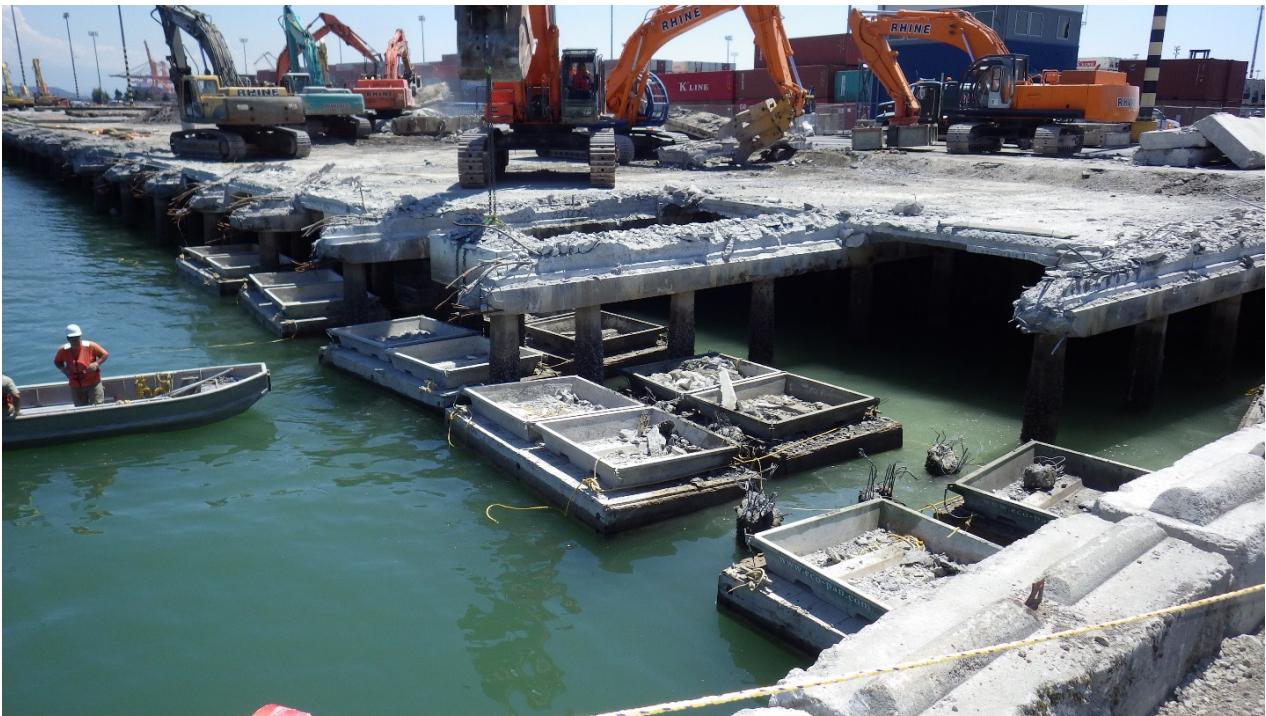
Photograph 5. Debris catching floats under deck demolition activities.

During deck demolition, Orion noted pre-existing damage to some pilings. During removal of the deck panels, some piles became separated from the pile caps and fell into the waterway. Orion conducted a diver survey and no broken piles were observed above the sediment line. Per Orion's Demolition Plan, in order to prevent deck debris from falling into the waterway, Orion made debris catching floats out of wood that were placed under active removal areas and moved according to where demolition was occurring (Appendix A, Photograph 5). The floats were emptied as necessary to prevent overloading or spillage of debris into the water. In order to allow access to under pier areas for saw cutting and chipping, a combination of floats and friction collar-supported access platforms were used. Any material on the floats was maintained so that debris was never submerged during a rising tide.

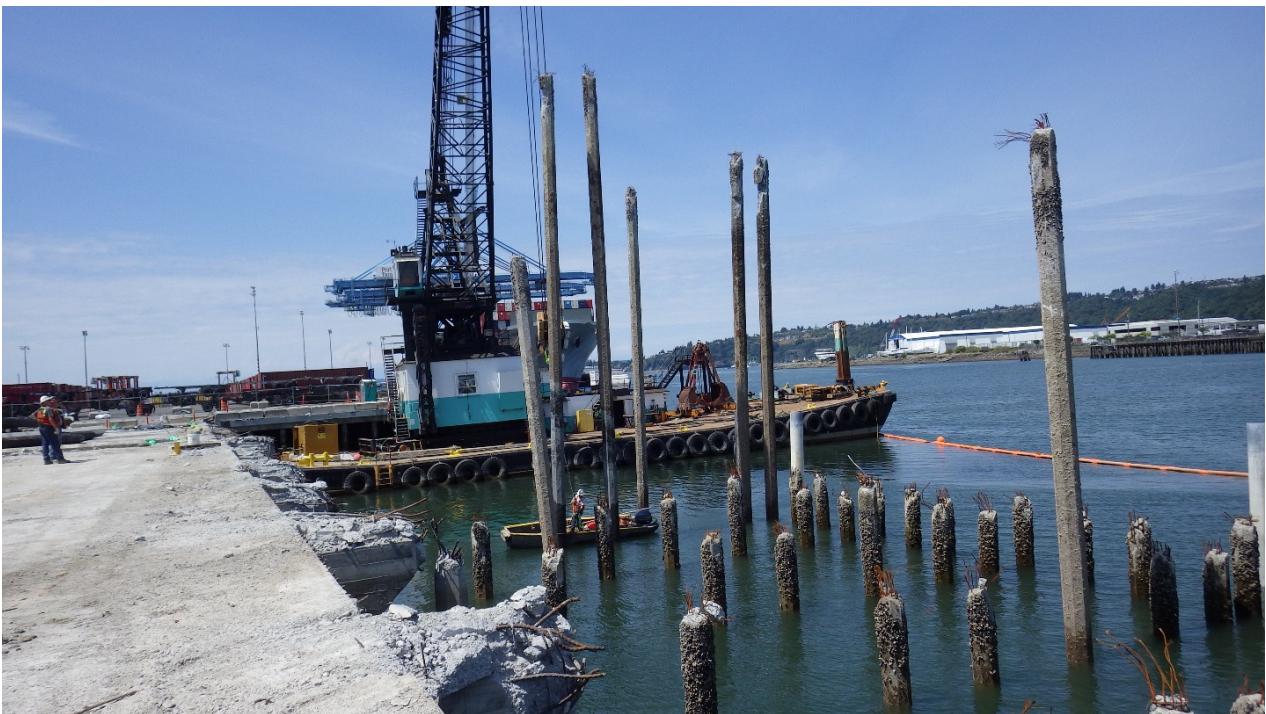
Photograph 6. Piles being removed and transferred to shore.

Piles were first extracted using a vibratory hammer (Appendix A, Photographs 6 and 7). Then, the piles were attached to rigging cables attached to the derrick barge and transported to shore where they were placed in a processing area to be broken into smaller pieces for eventual off-site disposal or recycling, depending on the pile type.

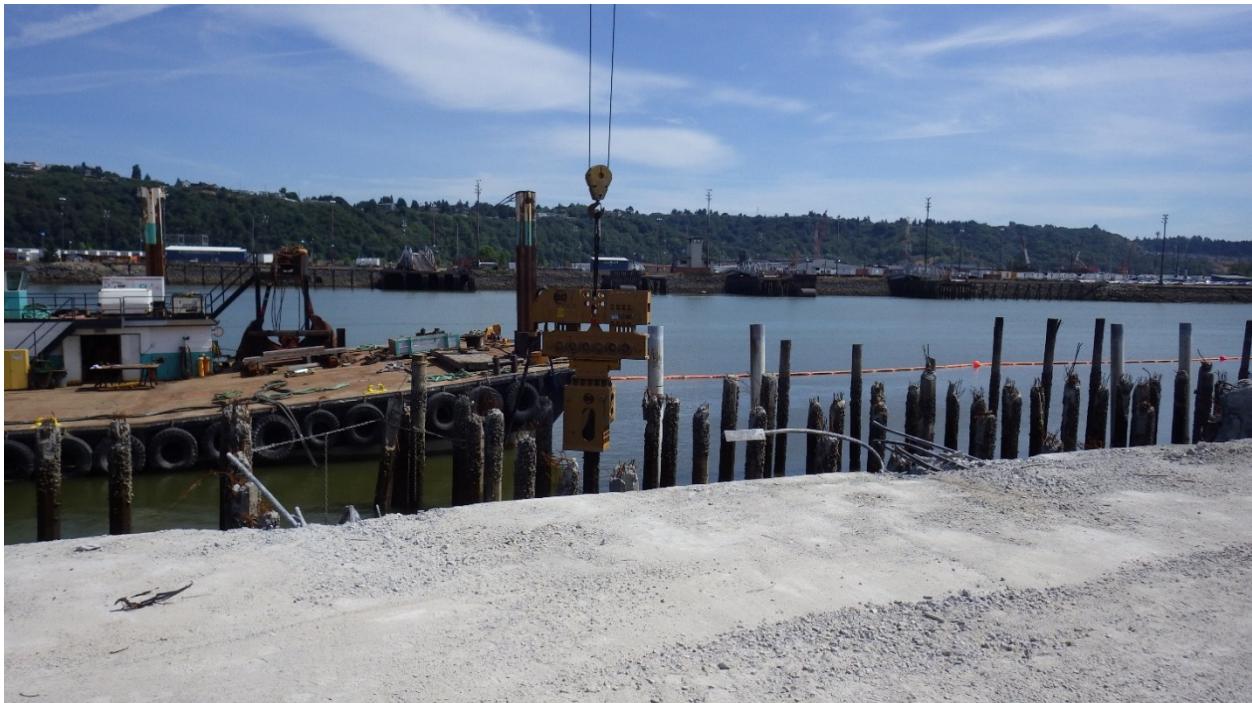
Photograph 7. Vibratory pile removal.

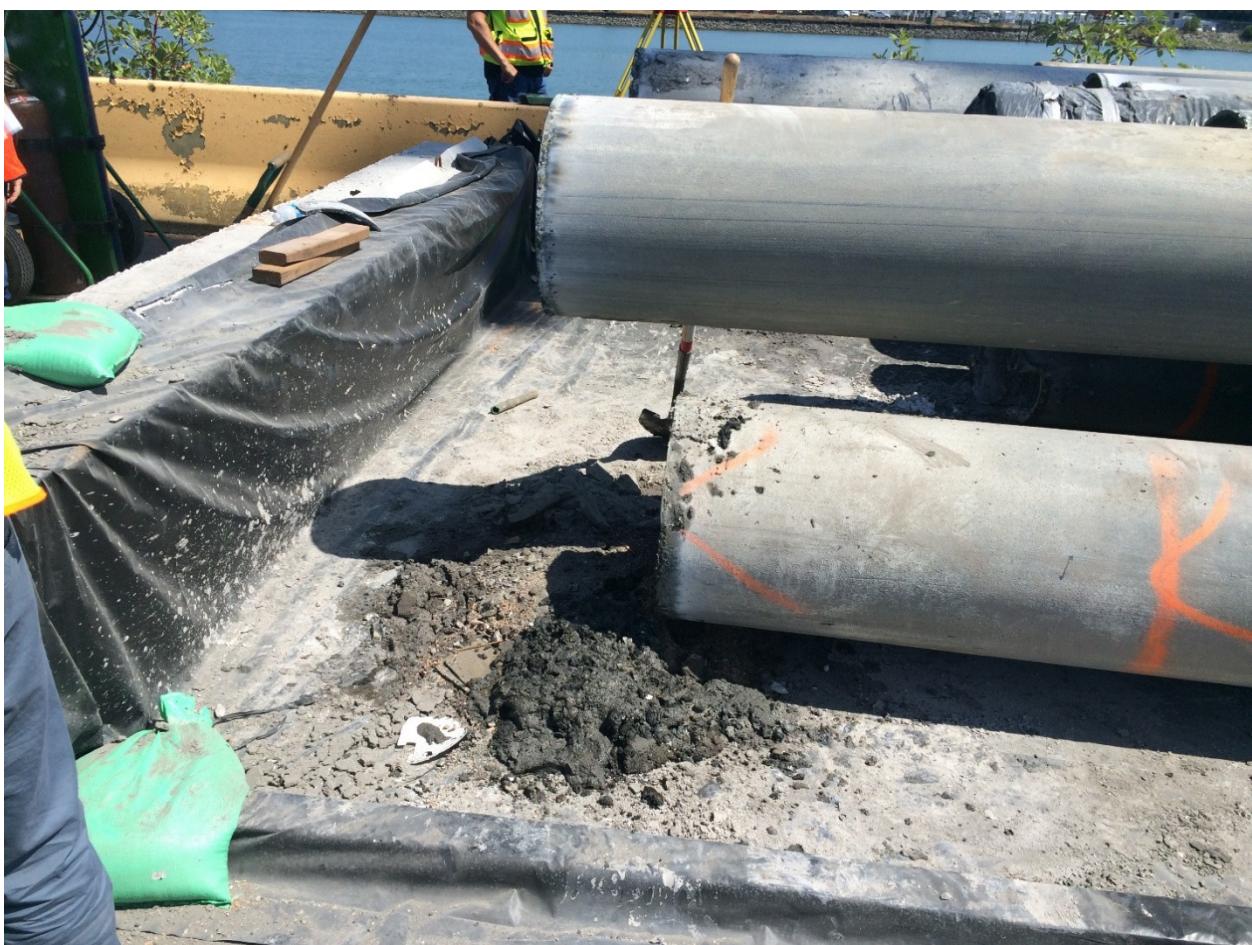
Photograph 8. Steel pipe piles with sediment.

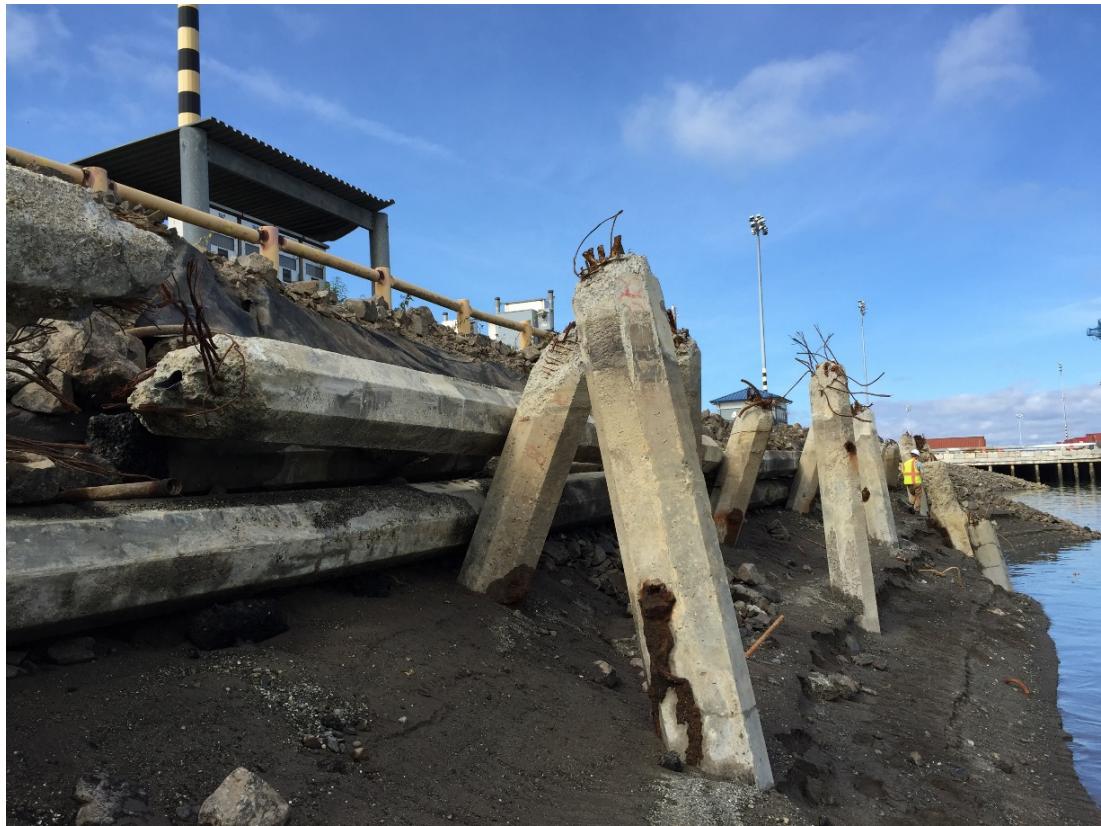
Photograph 9. Concrete pile remnants and in place piles for slope stabilization.

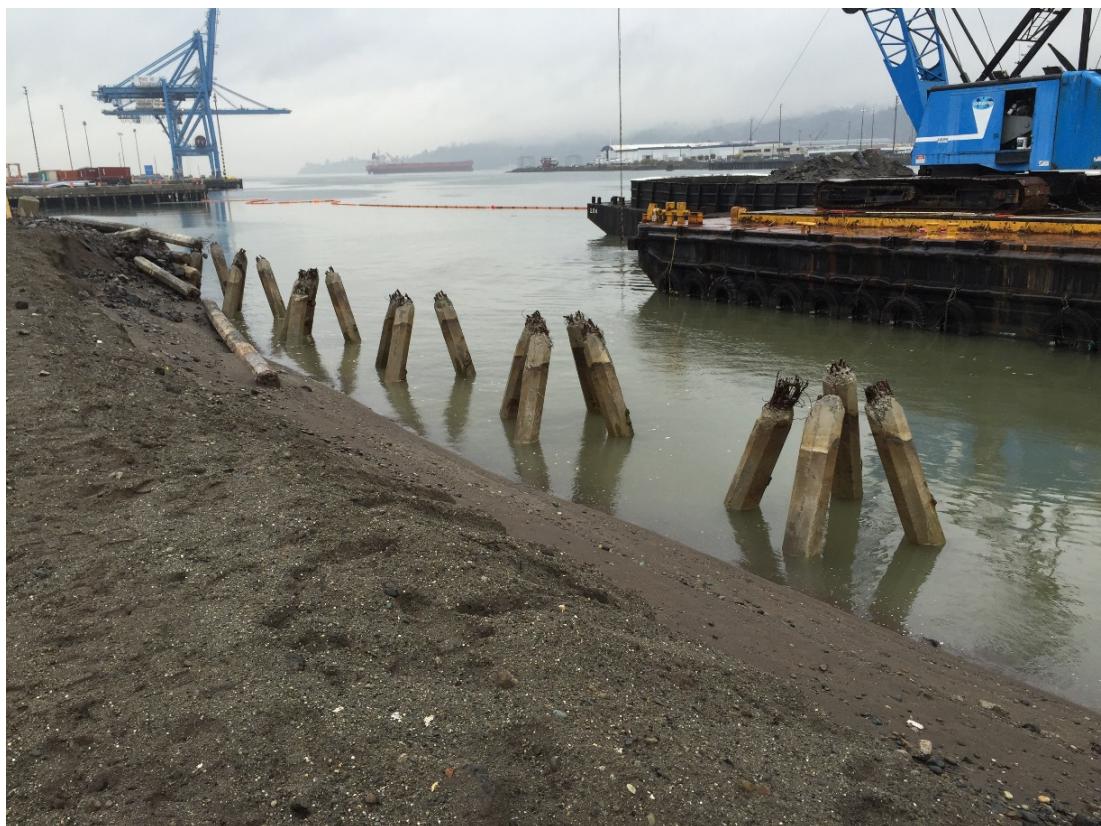
Photograph 10. Concrete piles left in place for slope stabilization.

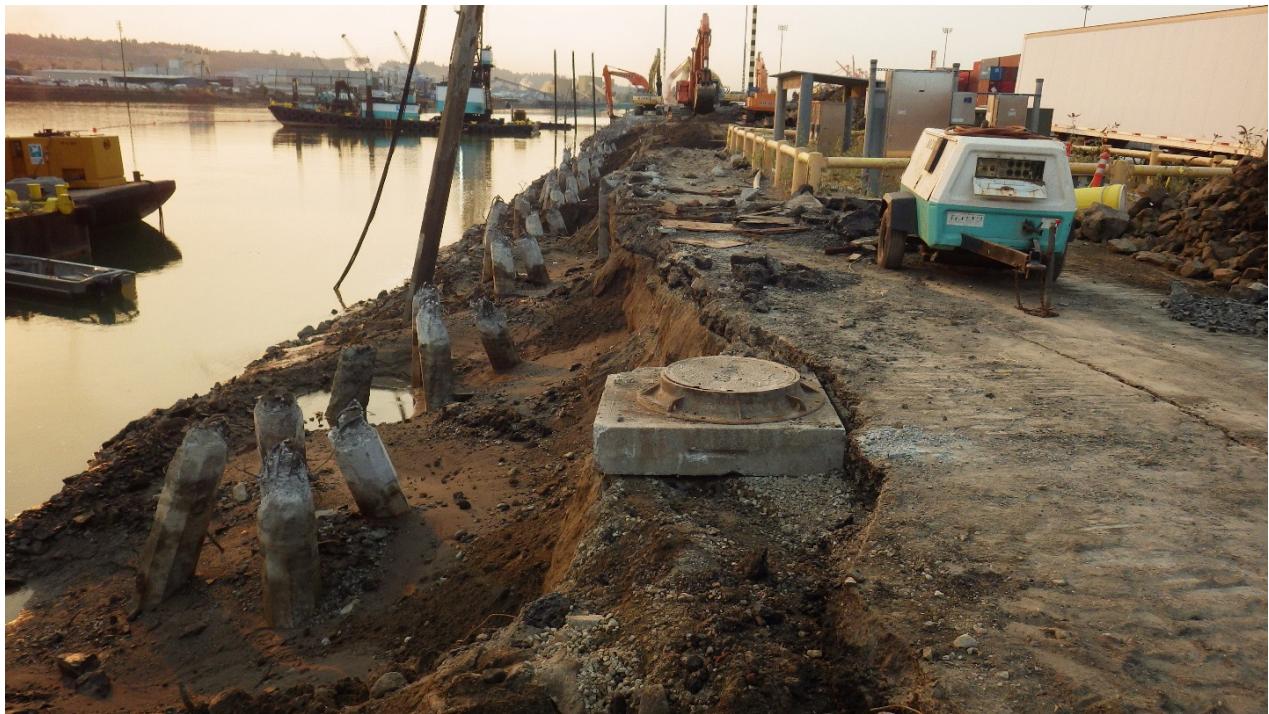
Photograph 11. In place concrete piles in front of substation.

On August 17, 2015, shoring consisting of a creosoted woodpile wall and lagging were observed on the north side of the electrical substation. In coordination with USEPA, this was left in place, as it is located outside of the Phase 1 dredge prism. A portion of the timber bulkhead will be removed as part of Phase 2 activities. Additional debris and creosoted woodpiles were found throughout the pile extraction work and were removed.

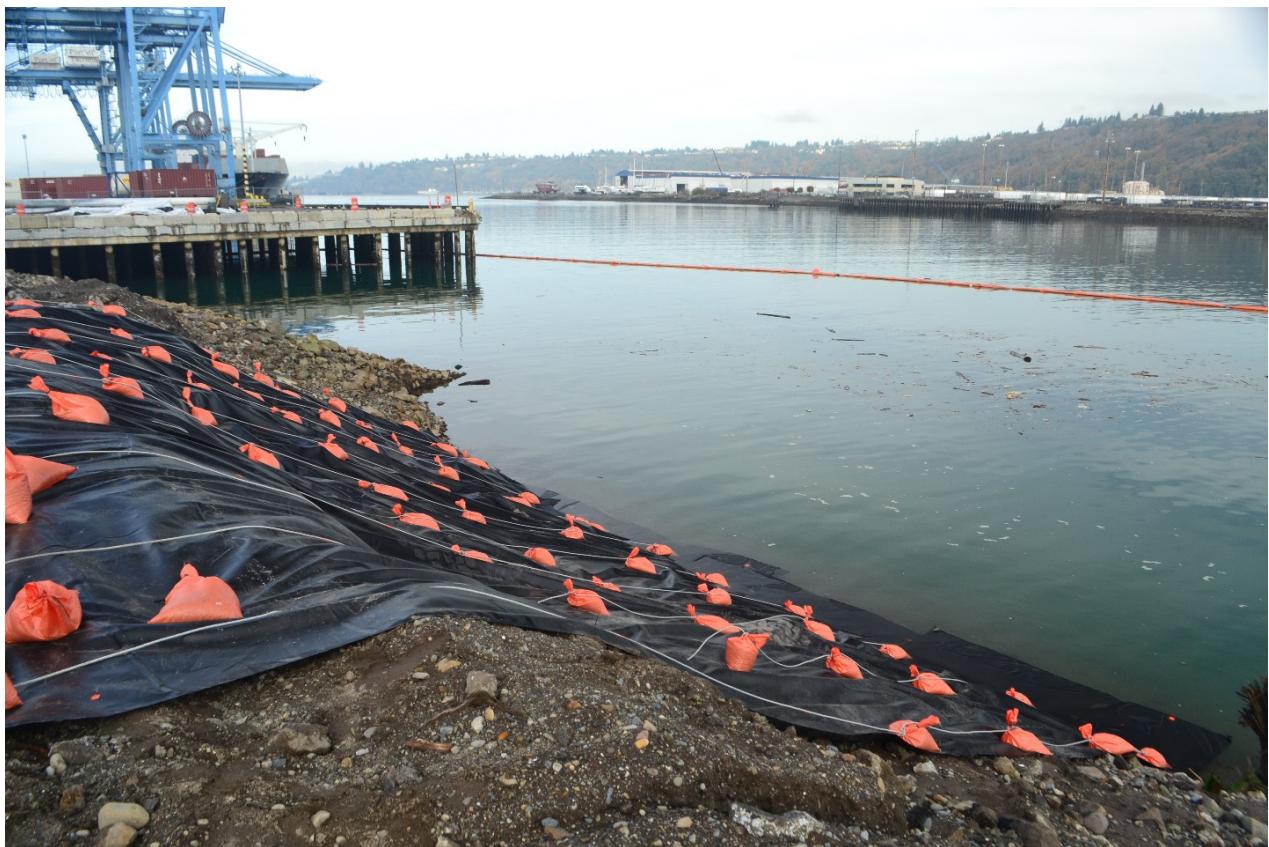
Photograph 12. Geotextile fabric and sand bags placed on slope for temporary erosion control.

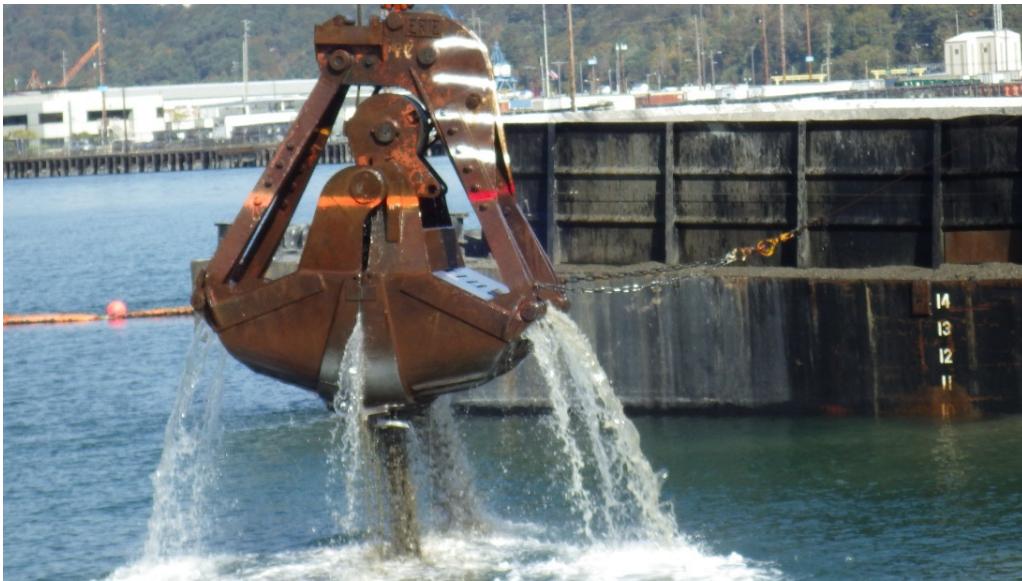
Photograph 13. Turbid water releasing from bucket during dredging.

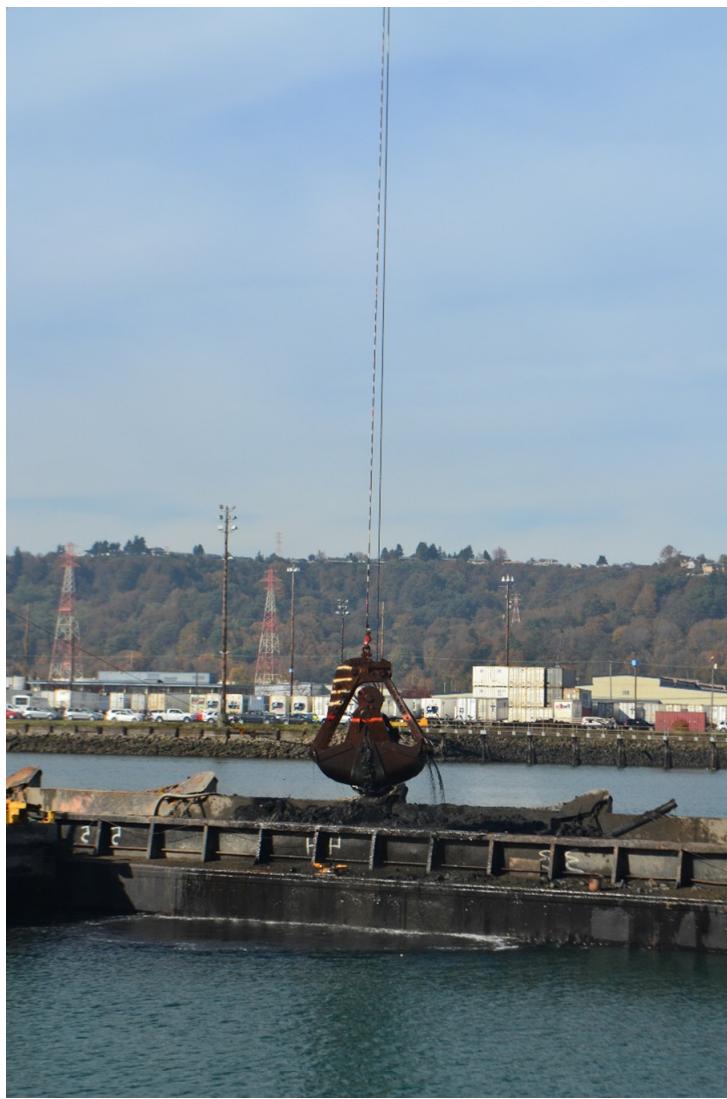
Photograph 14. Closed bucket during dredging.

Per the RAWP, the digging bucket was modified with a steel-fabricated “top hat” in order to close off the top of the dredge bowls to minimize sediment loss as the bucket was raised through the water column. The top hat was constructed between September 2 and September 11, 2015. To prepare for contaminated dredging, leak tests were conducted on the barges prior to use and all leaks observed were fixed prior to barge use.

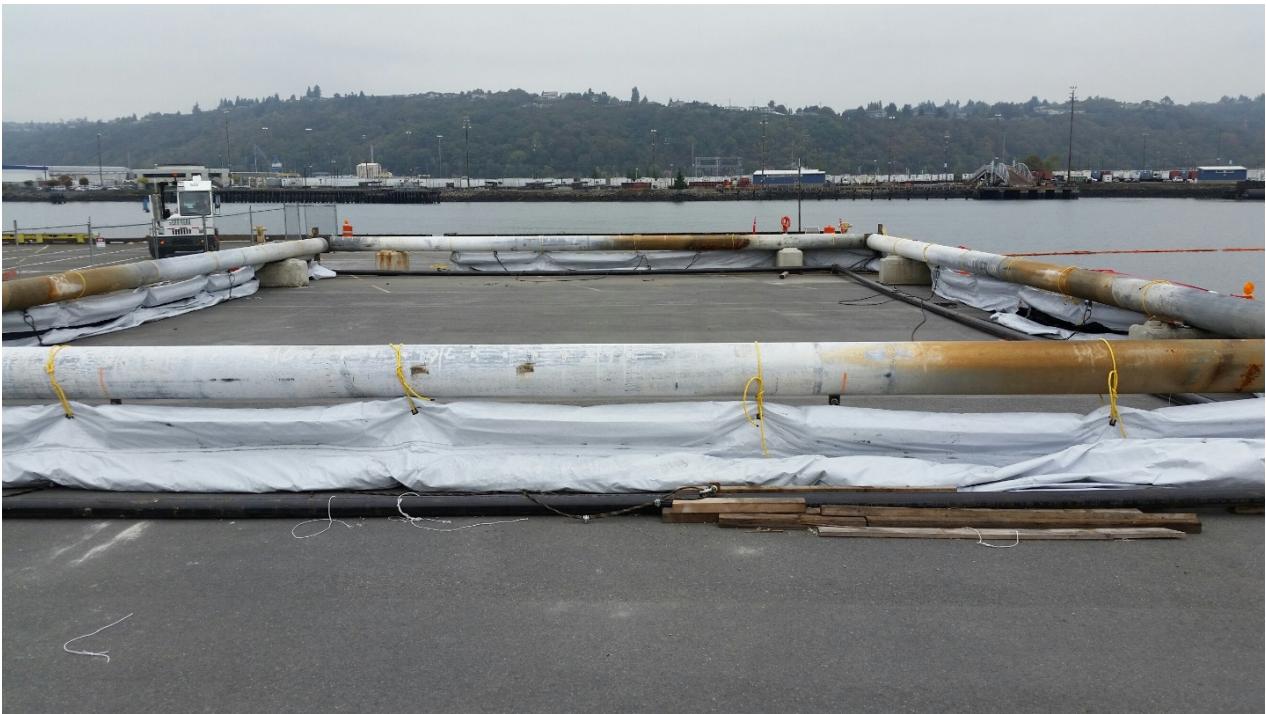
Photograph 15. Floating boom-supported turbidity curtain prior to deployment.
